Winter Storm Landon Action Update

MLGW Committee Debriefing
February 15, 2022

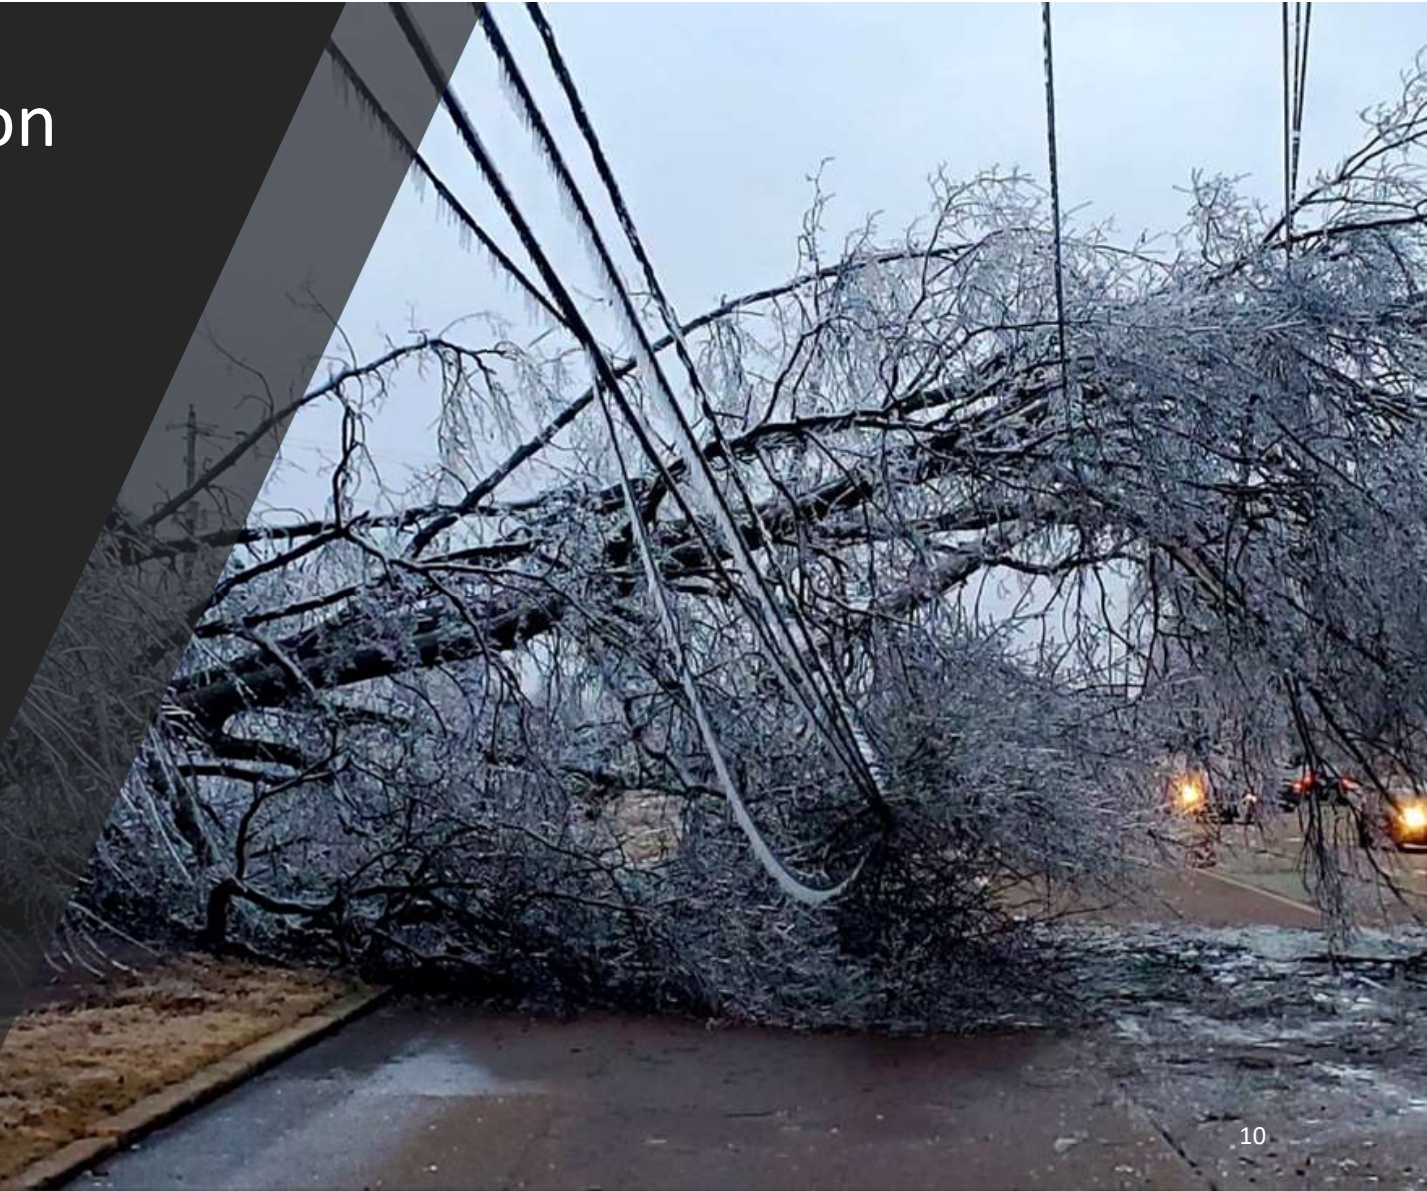
Ice accumulation on tree limbs causes limbs and entire trees to become heavy and to fall into power lines which can snap or affect poles

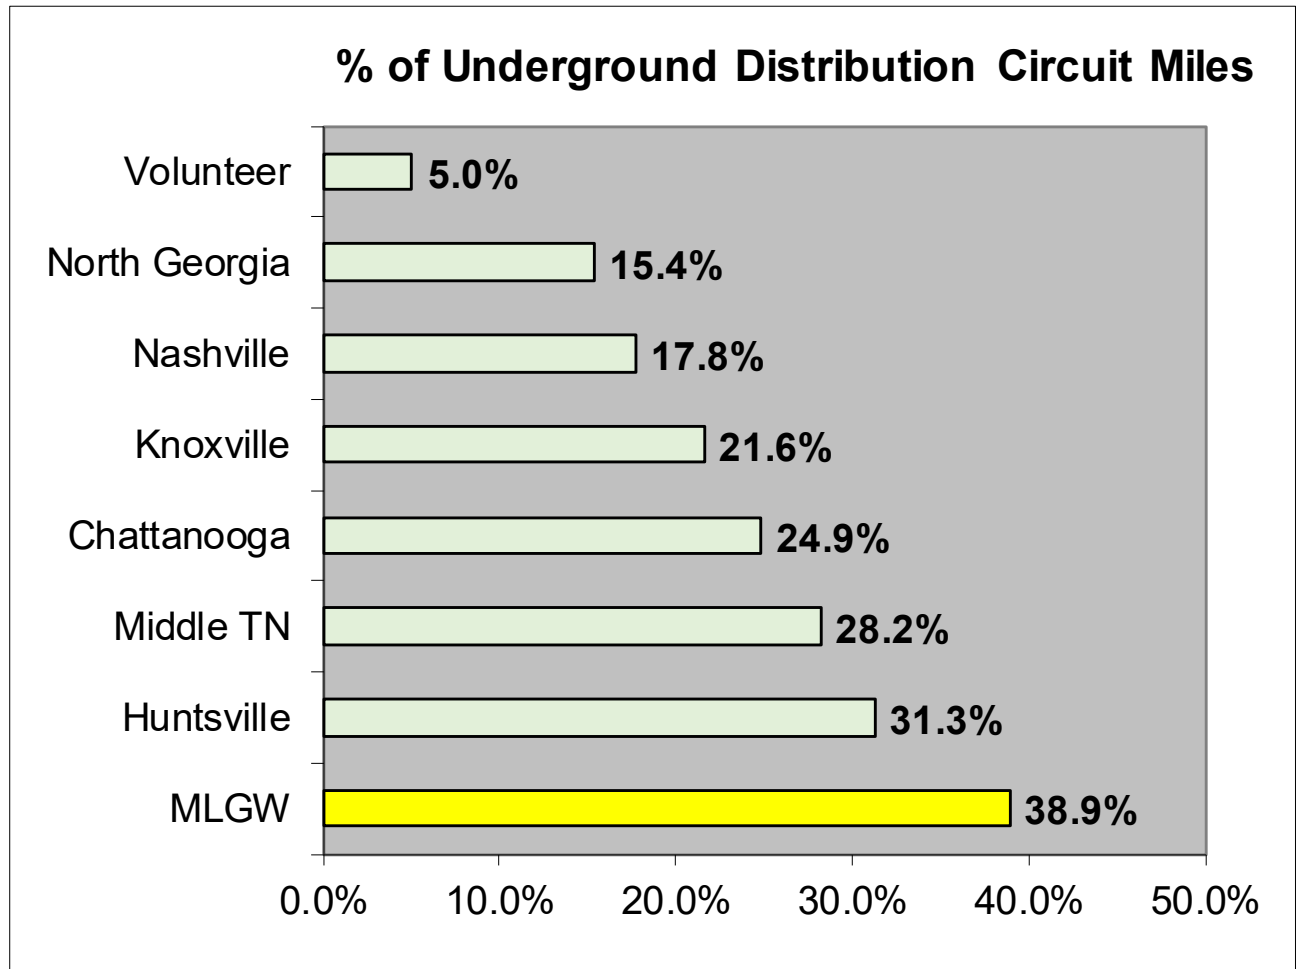
MLGW currently has almost 40% of its distribution system underground and that is the highest percentage among the Big 8 distributors in the Tennessee Valley.
